Corrosivity of road tunnel microclimate

Katerina Kreislova, Hana Geiplova, SVÚOM Ltd., Prague/Czech Republic; Roman Licbinsky, CDV, Brno/Czech Republic; Pavel Zak, CVUT, Prague/Czech Republic

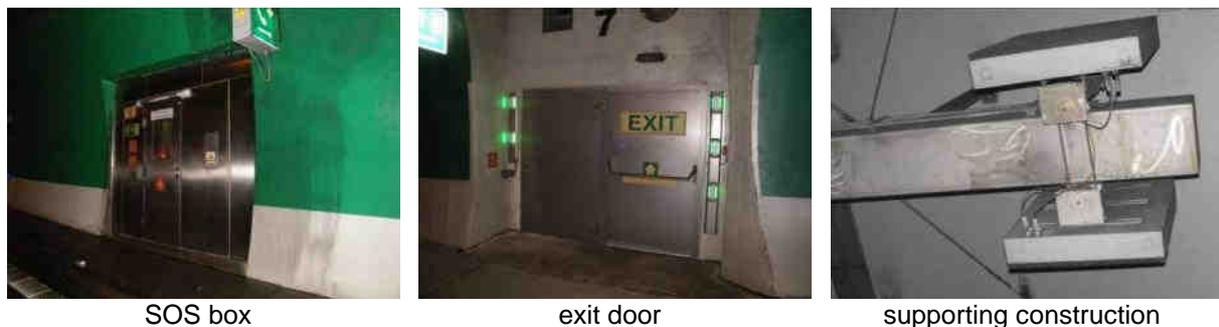
Figure 3: The examples of stainless steel application in the tunnel

The most intensive corrosion attack of materials used in tunnel construction is evaluated for stainless steels X5CrNi18-10 and X5CrNiMo17-12-2. These materials are used for SOS boxes, exit doors and various supporting constructions including fixing materials - screws and nuts (Fig. 3). The first sight of pitting corrosion was evident on stainless steel surfaces after 0.5 year of service (1 winter season) in Lochkov tunnel. After 1.5 years of service the critical attack was found on door surface in the 140 m distance from enter to tube (the higher chloride deposition) – Fig. 4d. The corrosion attack was more intensive on the other surface too in comparison to 0.5 year service evaluation.

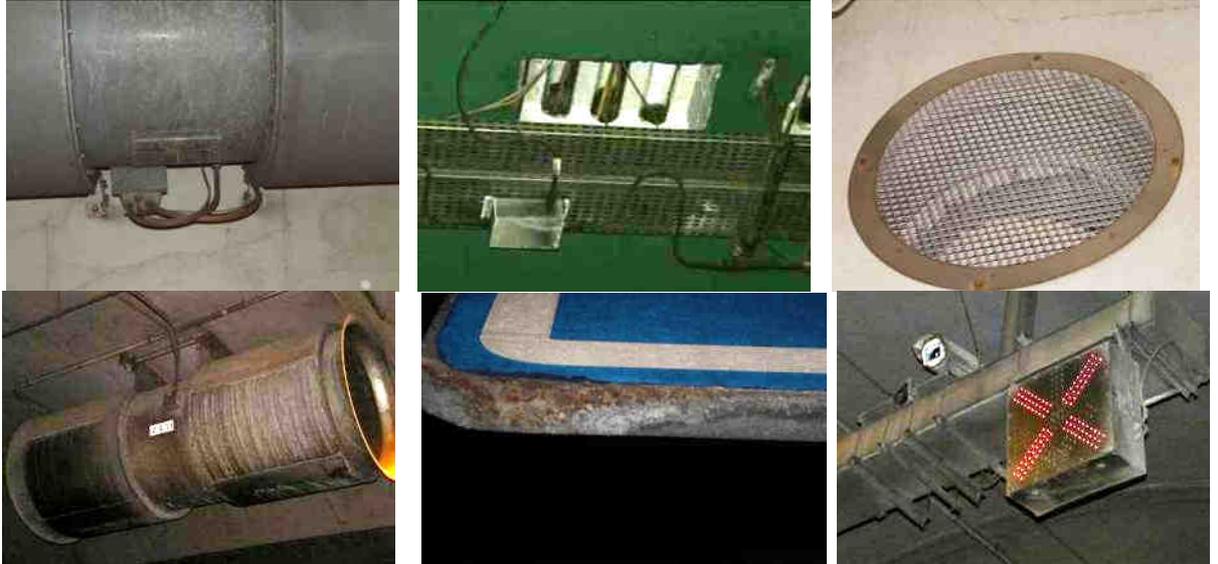
Figure 5: The examples of zinc coatings' corrosion on the tunnel equipments after 1.5 years (above) and 7 years of exposure in tunnels

There are used elements or products from galvanized steel for some application (Fig. 5); sometimes they are used as sublayer for duplex surface treatment. The intensive corrosion of galvanized steel, resp. duplex system, was found after 1.5 years in Lochkov tunnel. After 7 years of exposure the intensive corrosion of zinc coating was found (Mrazovka tunnel, Prague) – Fig. 5. There were found stainless steel screws on galvanized steel elements which create the conditions for galvanic corrosion.

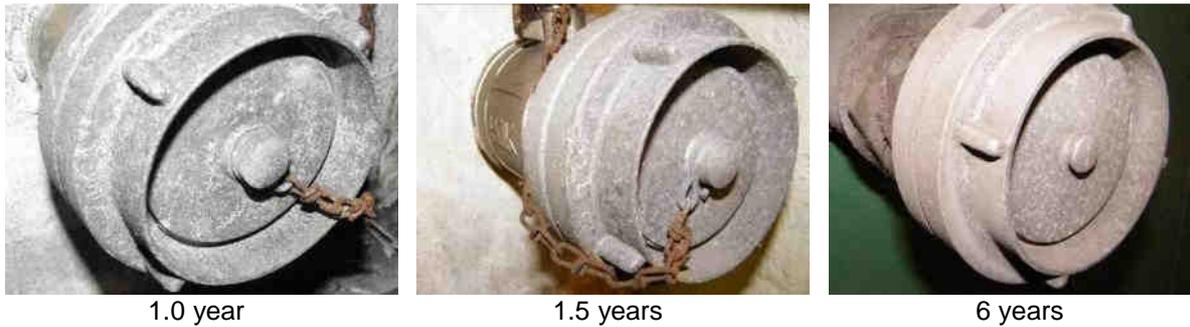
Figure 7: The examples of aluminium corrosion in the tunnels

The aluminium is used only in minor cases but its corrosion attack is very intensive (Fig. 6). There were found contact of aluminium and galvanized steel elements which

create the conditions for galvanic corrosion. The corrosion of other metaling material or coating was found after short exposure too.

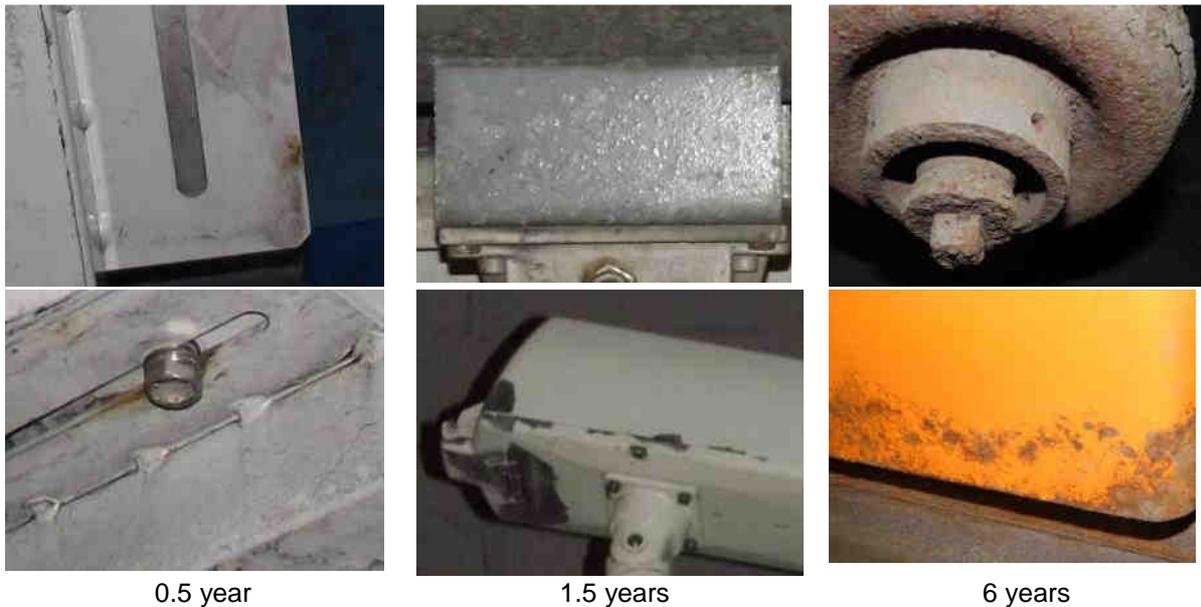
Figure 8: The examples of coating failure

The failure of organic coatings applied on carbon steel, cast iron and galvanised steel surfaces/elements started after 0.5 years of exposure as corrosion of substrate metals on edges of elements and continue by blistering, filliform corrosion and peeling off after 1.5 years of exposure to massive rusting after 6 years of exposure (Fig. 7). The type and intensity of failure depends on type of coating and exposure conditions (location of exposure).

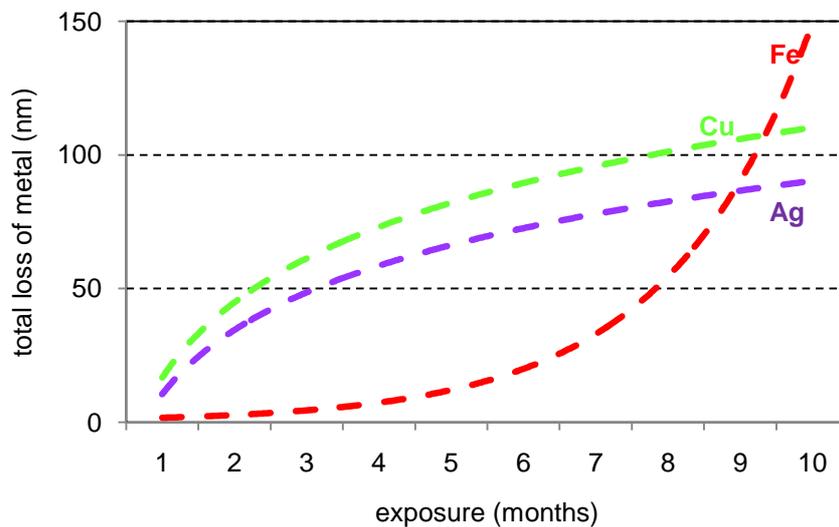
Figure 12: Corrosion loss measured by resistance sensors

The results of measurement are given on Figure 12. According to ISA Standard S71.04 reactivity monitoring the tunnel environment can be classified as class C3 for copper (moderate) – corrosion loss average value was $223 \text{ \AA}/30 \text{ days}$, but during some most corrosive months even to C4 (harsh) – $335 \text{ \AA}/30 \text{ days}$. The class S3 was

estimated for silver (moderate) - corrosion loss average value was 114 Å/30 days and 170 Å/30 days during some most corrosive months.

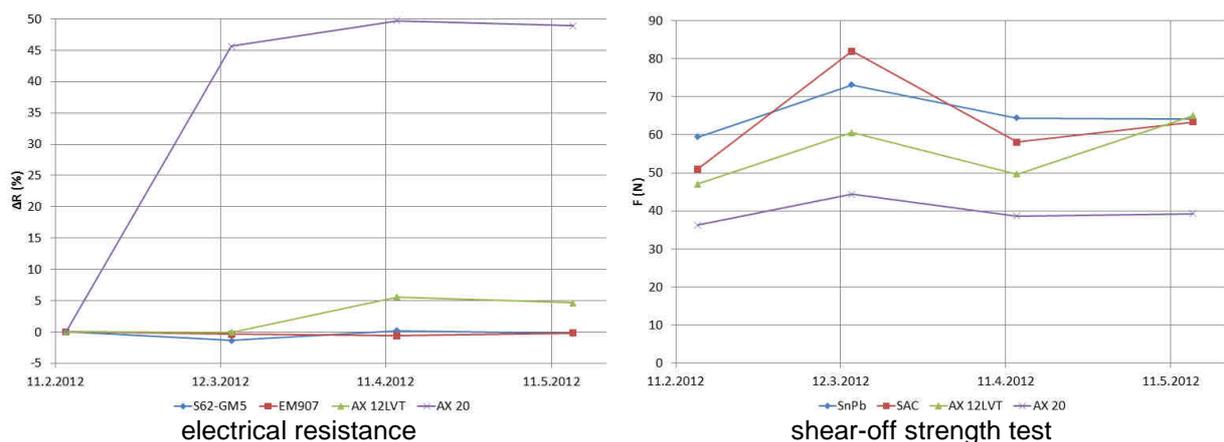
Figure 13: Corrosion loss measured by resistance sensors

- resistance sensor Fe failed after 2 months and had been replaced (details of surface see Fig. 13a); the second resistance sensor failed after 4 months;

- resistance sensor Cu failed after 4 months and had been replaced (details of surface see Fig. 13b); the second resistance sensor failed after 2 months;
- resistance sensor Ag failed after 9 months.

These samples are withdrawn in month intervals and the basic characteristics of their properties are measured (electrical resistance and shear-off strength test). After 2 months of exposure the electric resistance of metallic solders are without changes but for both adhesives shows decreasing of electric conductivity, especially one component conductive adhesive AX 20 – Fig. 13.

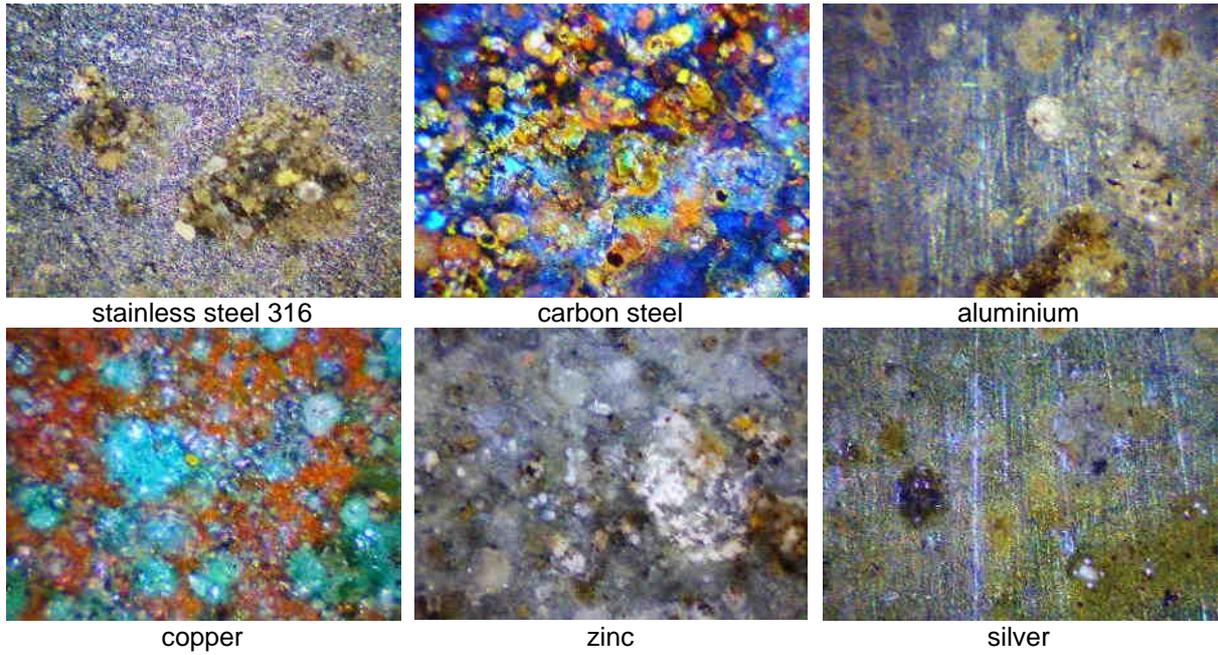
Figure 14: Corrosion products and deposited particles on metal surfaces after 10 months exposure

The corrosion attack of exposed corrosion coupons is very intensive for all exposed metals. The surfaces of them are covered by deposition of different particles and corrosion products. The most intensive corrosion attack occurred on carbon steel, copper and zinc (Fig. 14).

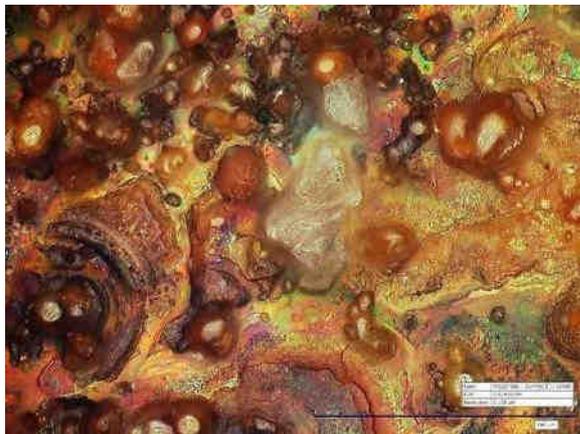
carbon steel, 2 months in tunnel

The corrosion product layer of carbon steel and copper is shown after 2 months, resp. 4 months of exposure, on Fig. 15. There are evident black carbon particles and particles of salt on the surface of metals. The chemical compositions of exposed metallic surfaces of carbon steel, copper and silver (exposed for 9 months) are given in Table 5. The analysis confirms the effect of chloride onto corrosion attack of exposed metals. As the silver sensor had been exposed for 9 months the corrosion products and deposits contain higher concentration of corrosion stimulators (Cl, S).
