Corrosivity of road tunnel microclimate

Katerina Kreislova, Hana Geiplova, SVÚOM Ltd., Prague/Czech Republic; Roman Licbinsky, CDV, Brno/Czech Republic; Pavel Zak, CVUT, Prague/Czech Republic

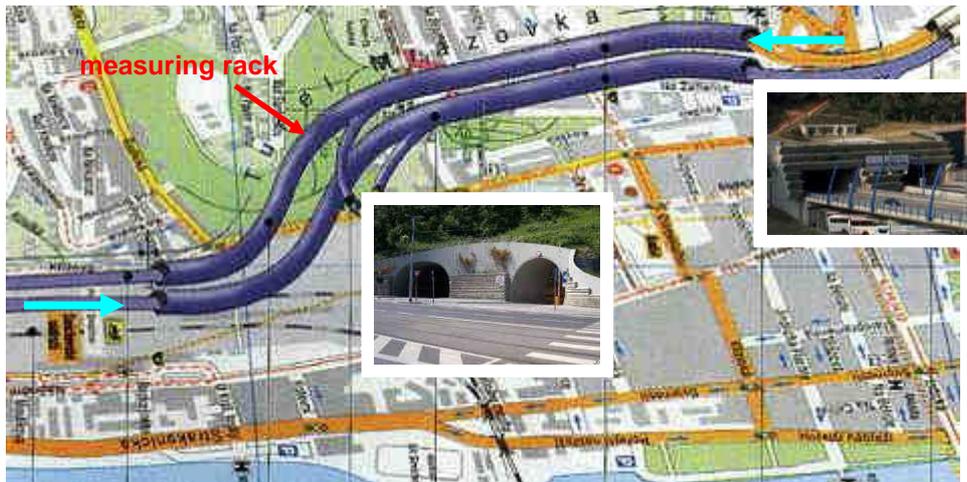
Figure 9: Mrazovka tunnel and measuring rack location

The field study in tunnel started in 07/2011. The Mrazovka tunnel comprises two unidirectional tunnel tubes, each with a triple-lane profile, two-lane and single-lane sections, bifurcation chambers, 5 cross passages, a cavern for a transformer station and a cavern for ventilation plant, which is connected to a ventilation shaft. The tunnel is roughly 1.300 m long; the total length of the mined sections is about 2.200 m. The measuring locality in Mrazovka tunnel is in the west, slope down tube, approx. in 2/3 distance from enter to the tunnel (Fig. 9).

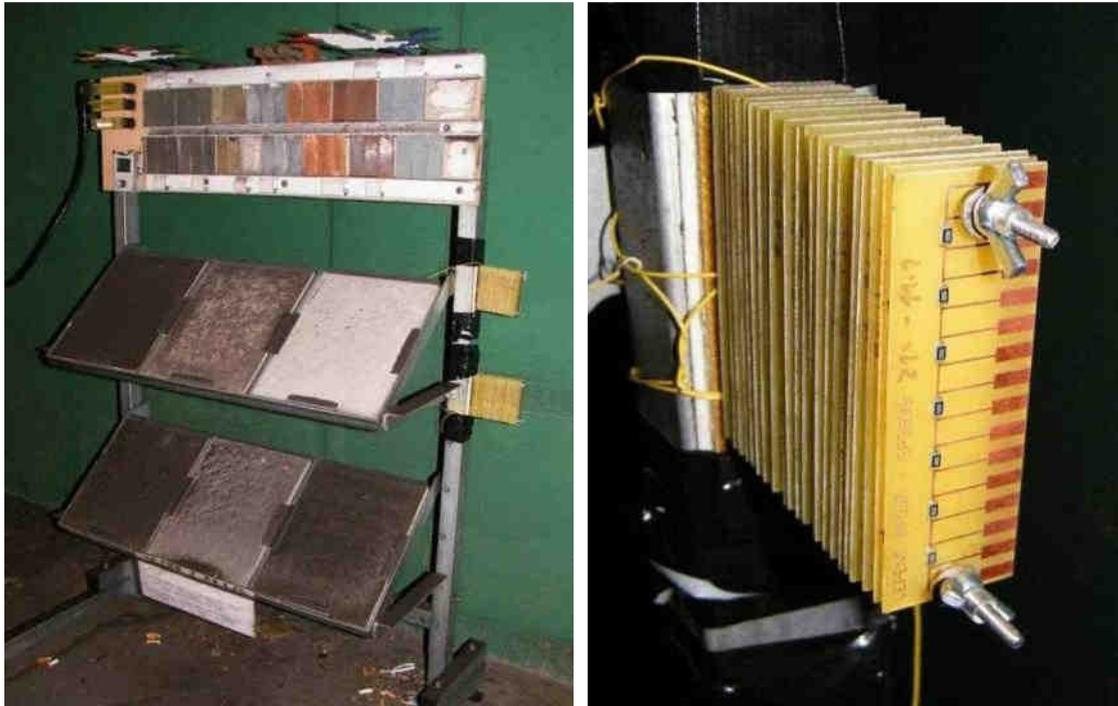
Figure 11: Rack with passive samplers and exposed metal coupons, resistive sensors and PCB with SMD attachments

On rack there are exposed the corrosion coupons of stainless steels X5CrNi18-10 and X5CrNiMo17-12-2, carbon steel, copper, aluminium, zinc and silver, too (Fig. 11). These metals represent the most exposed materials found for tunnel infrastructure (see above). The silver coupons are made as electrodeposited coating on copper substrate. The corrosion attack was visually evaluated in monthly intervals and corrosion mass loss will be estimated after 1 year exposure.

In 02/2012 the samples of 2 types of soldered joints and 2 types of electrically conductive adhesives were exposed (see Fig. 11b):
